THE WALT DISNEY STUDIOS, SERVICE STATION
(Building 30)
Corner of Alameda Avenue and Buena Vista Street
Burbank
Los Angeles County
California

HABS No. CA-2639B

HISTORIC AMERICAN BUILDINGS SURVEY

HISTORIC AMERICAN BUILDING SURVEY
THE WALT DISNEY STUDIOS, SERVICE STATION

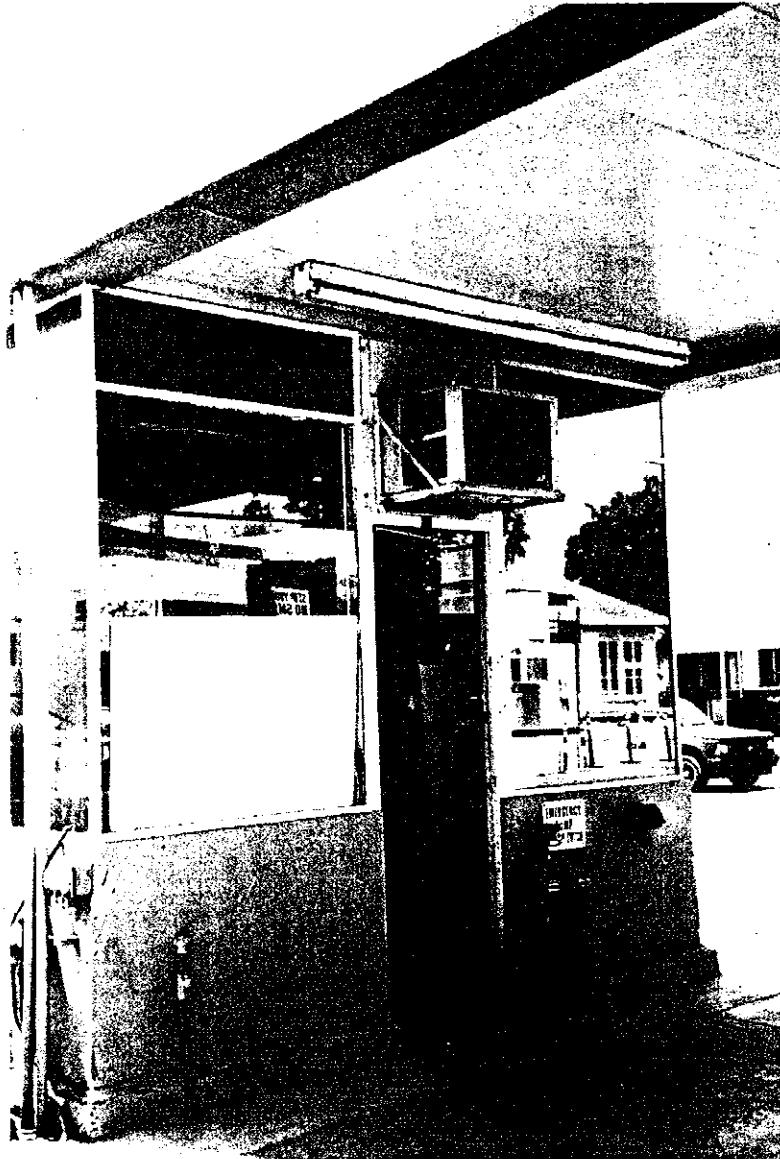
Aside from this, the main components of the Service Station appear to be unaltered. Basic visual inspection cannot reveal any replacement of building materials, although the possibility cannot be ruled out. An air conditioning unit has been added to the exterior of the east side of the office (supplemental photo C). Upgraded mechanical equipment has been added to the office, and the alteration of some of the storage cabinets on the office's interior is also evident. Original suspended lighting fixtures have been replaced by fluorescent lamps.

An electrical air conditioning unit has been added to the office. This unit takes the place of the transom window over the east door of the office (photo CA-2639-B-9, supplemental photo C).

Three gasoline pumps are located on each pump island. A "Fuel Lock" computerized gasoline dispensing system has been installed in the building and the pumps, incorporating an emergency pump cutoff switch. The terminal for the system is located inside the office, and the fuel cutoff is located on the east exterior wall of the office (photo CA-2639-B-9, supplemental photo C).

C-- Exterior east side elevation, facing northwest

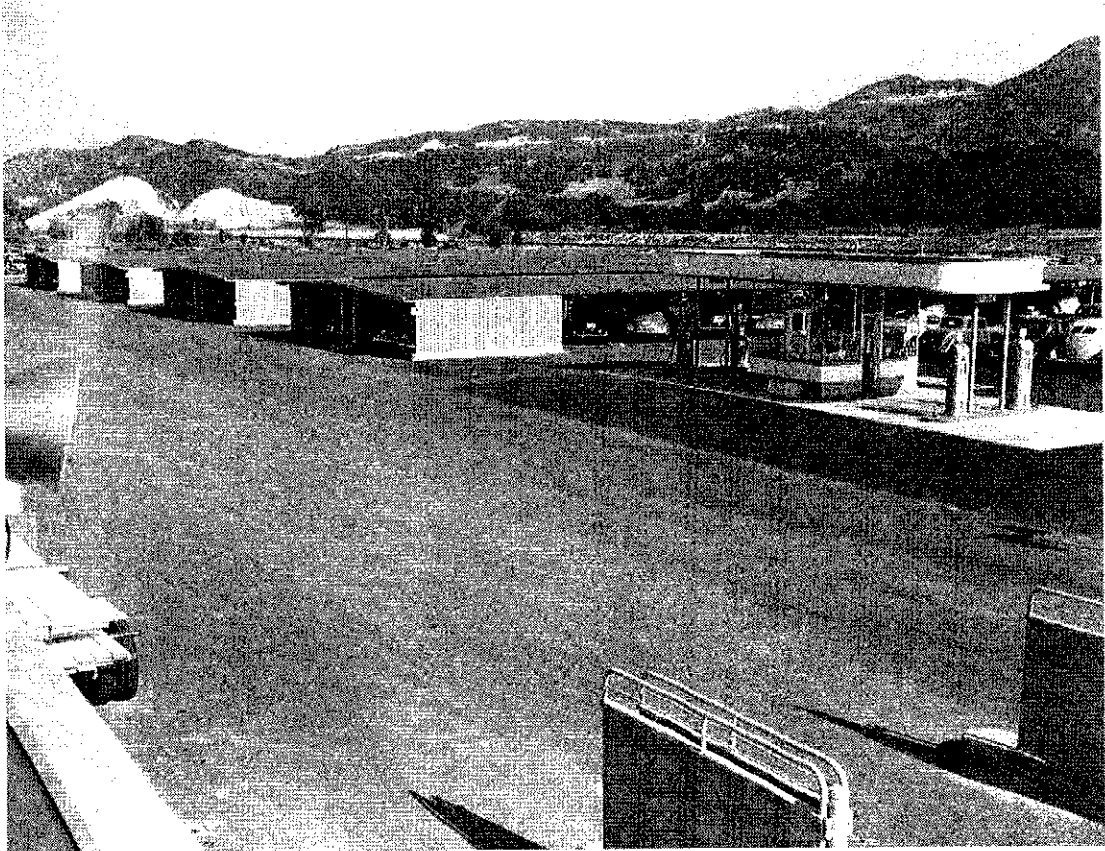
The 1940 photograph of the Service Station reveals that the columns which support the canopy-roof structure originally extended directly down to the service islands (supplemental photo L). At some point, possibly when the number of gasoline pumps on the pump islands was increased from two to three, the columns were cut and a beam was added which carried the load out to the ends of the islands (photo CA-2639-B-5). The footprint of the truncated columns still exist at the top of the islands.

L-- Historic image: overall site view, facing southeast (1940)
Disney Archives negative #69-109-4
©Walt Disney Company. NOT FOR REPRODUCTION.
